PERMIT NUMBER: NYR11I563

INSPECTION REPORT #118

Baker Rd/Dunlap Ave/ South Street Rd, Marcellus

10/25/23 3:00 pm

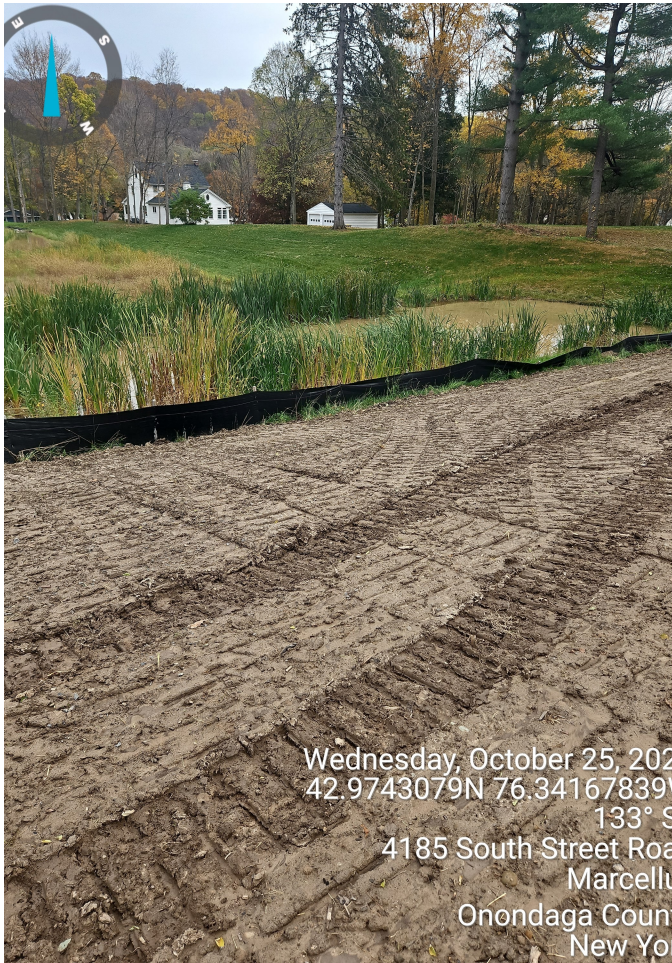
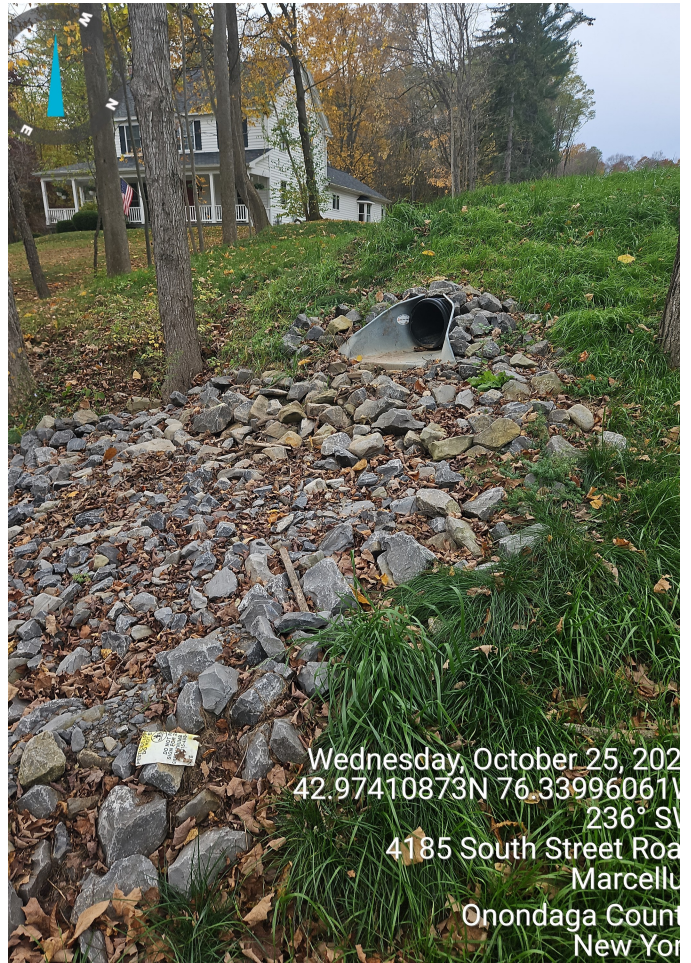
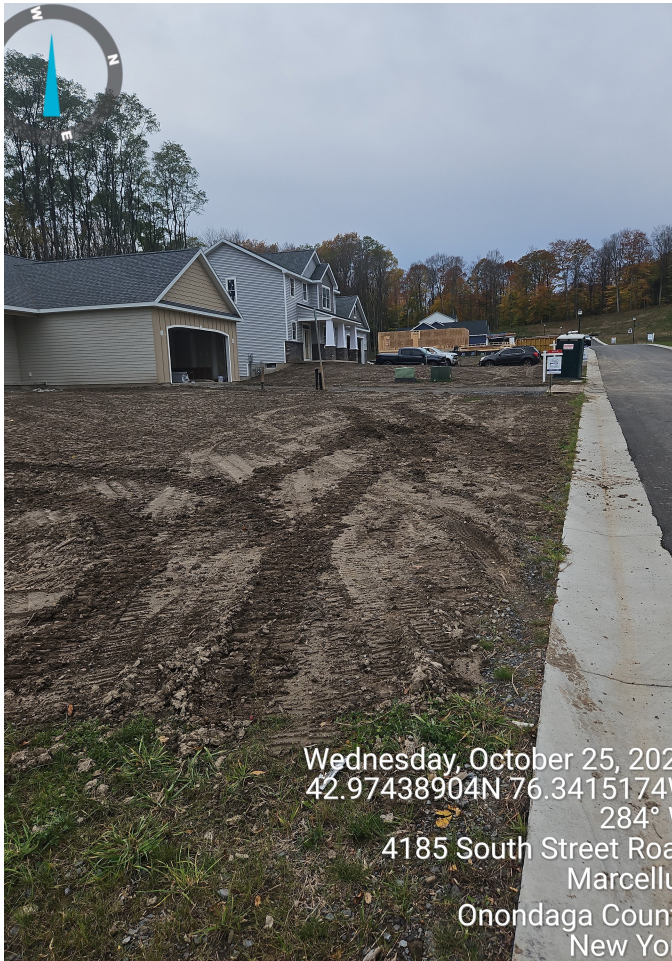
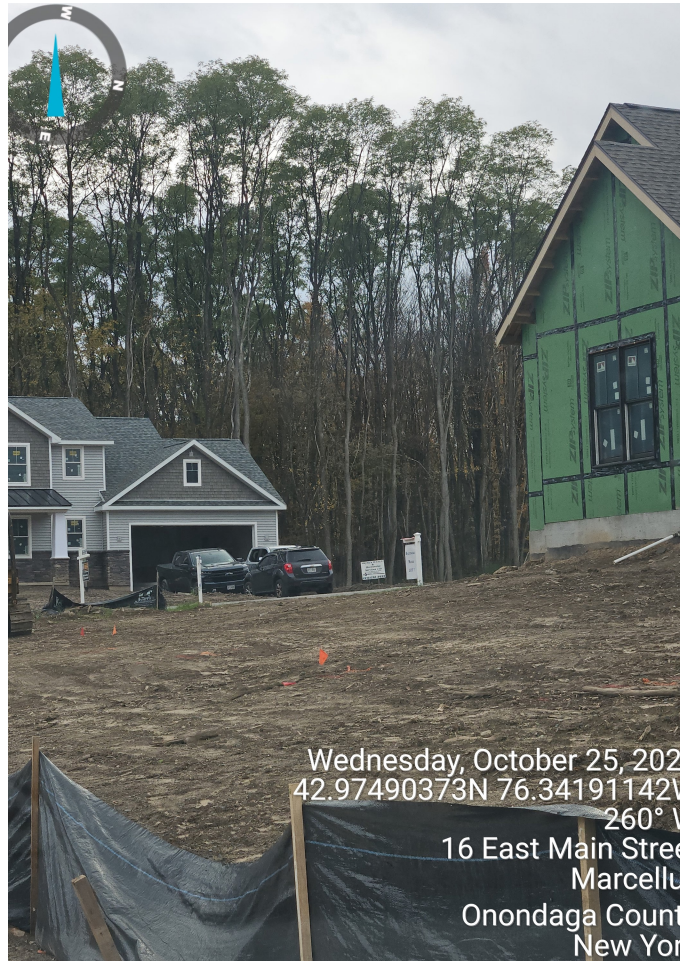
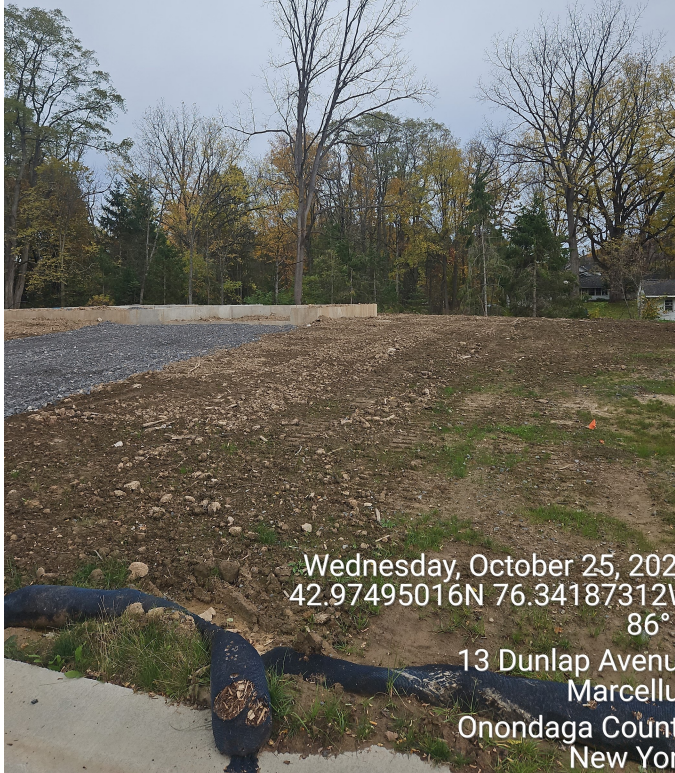
Home construction taking place at the time of inspection  
No discharge from pond
